Collapse of the Peace River Bridge

David Cruden

February 5, 2014

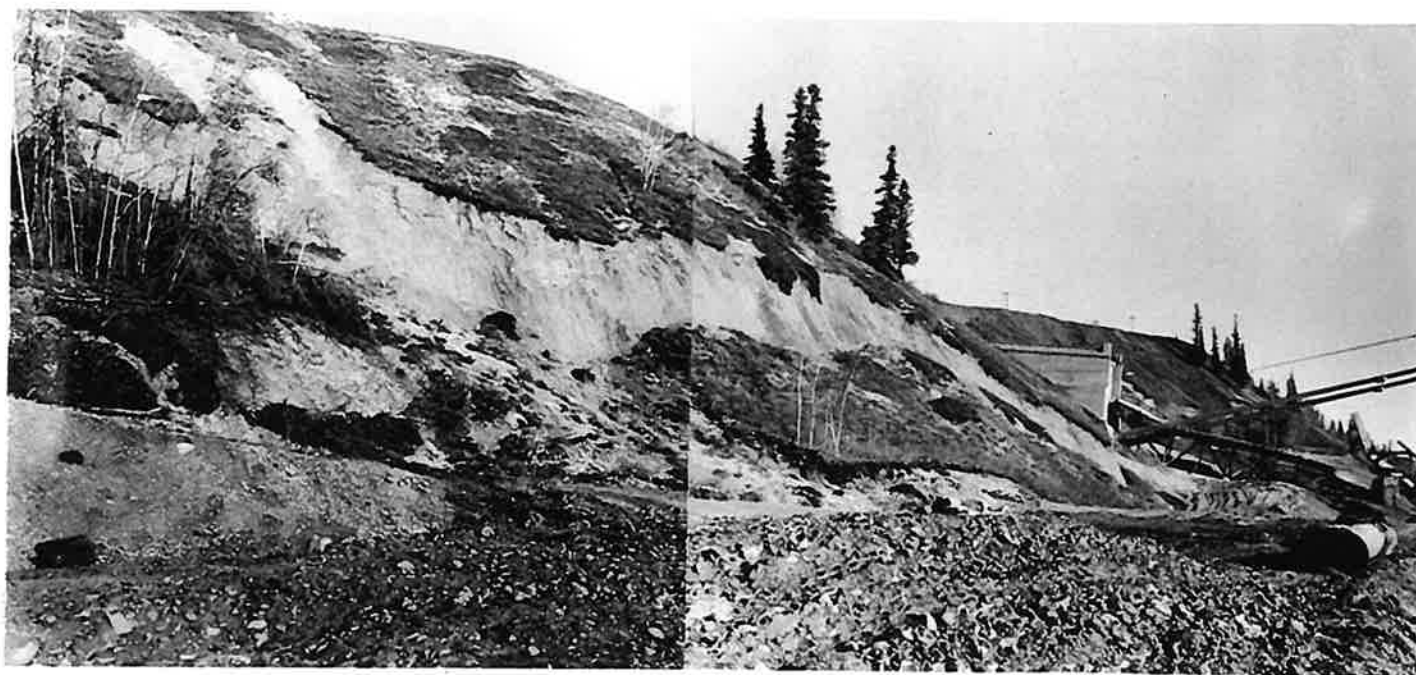
About 11 p.m. on 15 October 1957, the bridge was closed to traffic by an unusual subsidence, or movement of the shale rock, at the north abutment. Over the next 12 hours, a landslide on the north bank carried a million cubic metres of shale — and the anchor block — several metres towards the river, overstressing the suspension cables and eventually rupturing the cables that carried the load of the bridge deck up to the suspension cables from the side span. While the side span and the cable supports collapsed into the river, the towers of the suspension bridge, though damaged, remained standing. Hundreds of spectators — the result of jammed-up, southbound traffic on the Alaska Highway — watched the severing of an important link with southern Canada; no one was injured.

Figure 3. View from west of scarp of landslide, North abutment and collapsed approach span in background

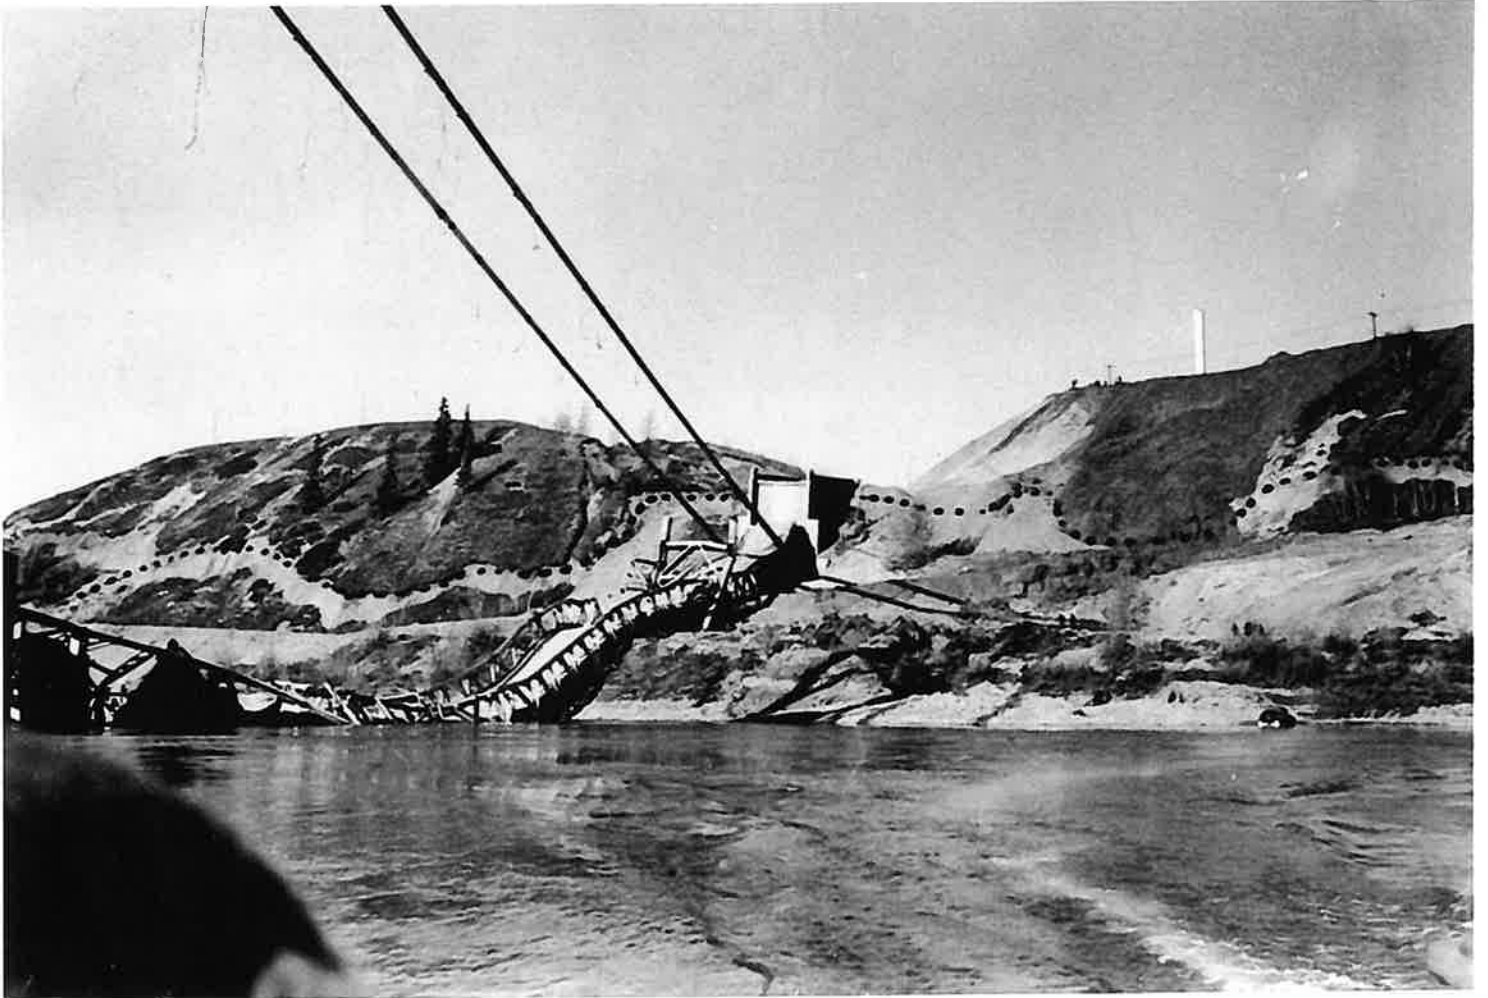
Figure 4. View from the south east of North span and approach span collapsed. Note snapped suspender cables. The dotted line traces the scarp of the slide.

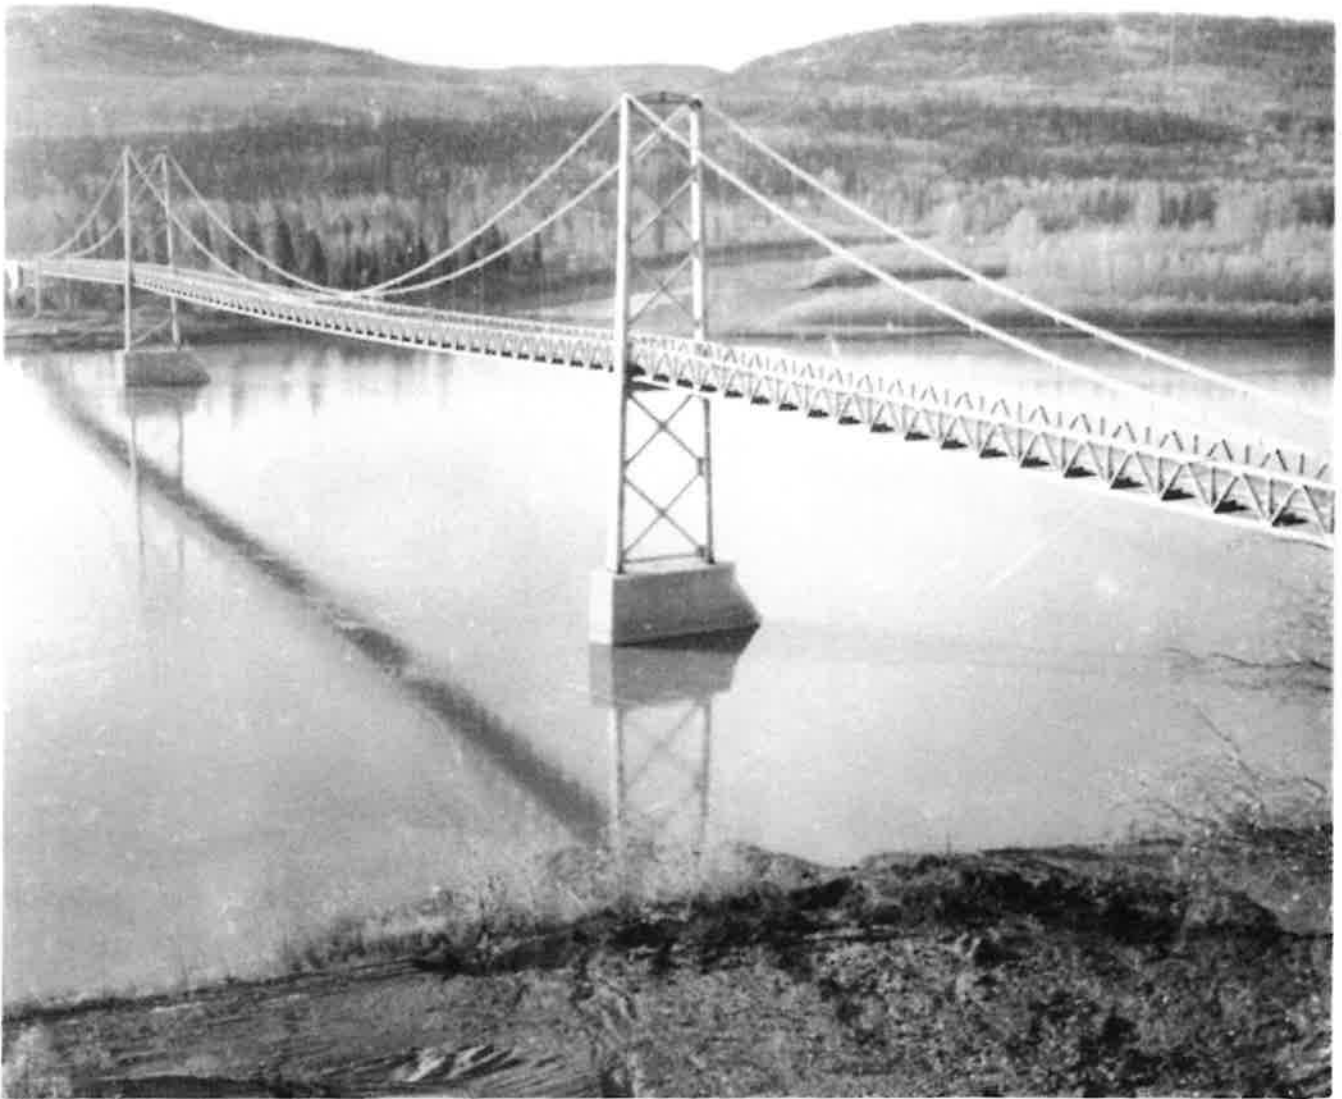
Figure 5. General view from northeast, 16 October.

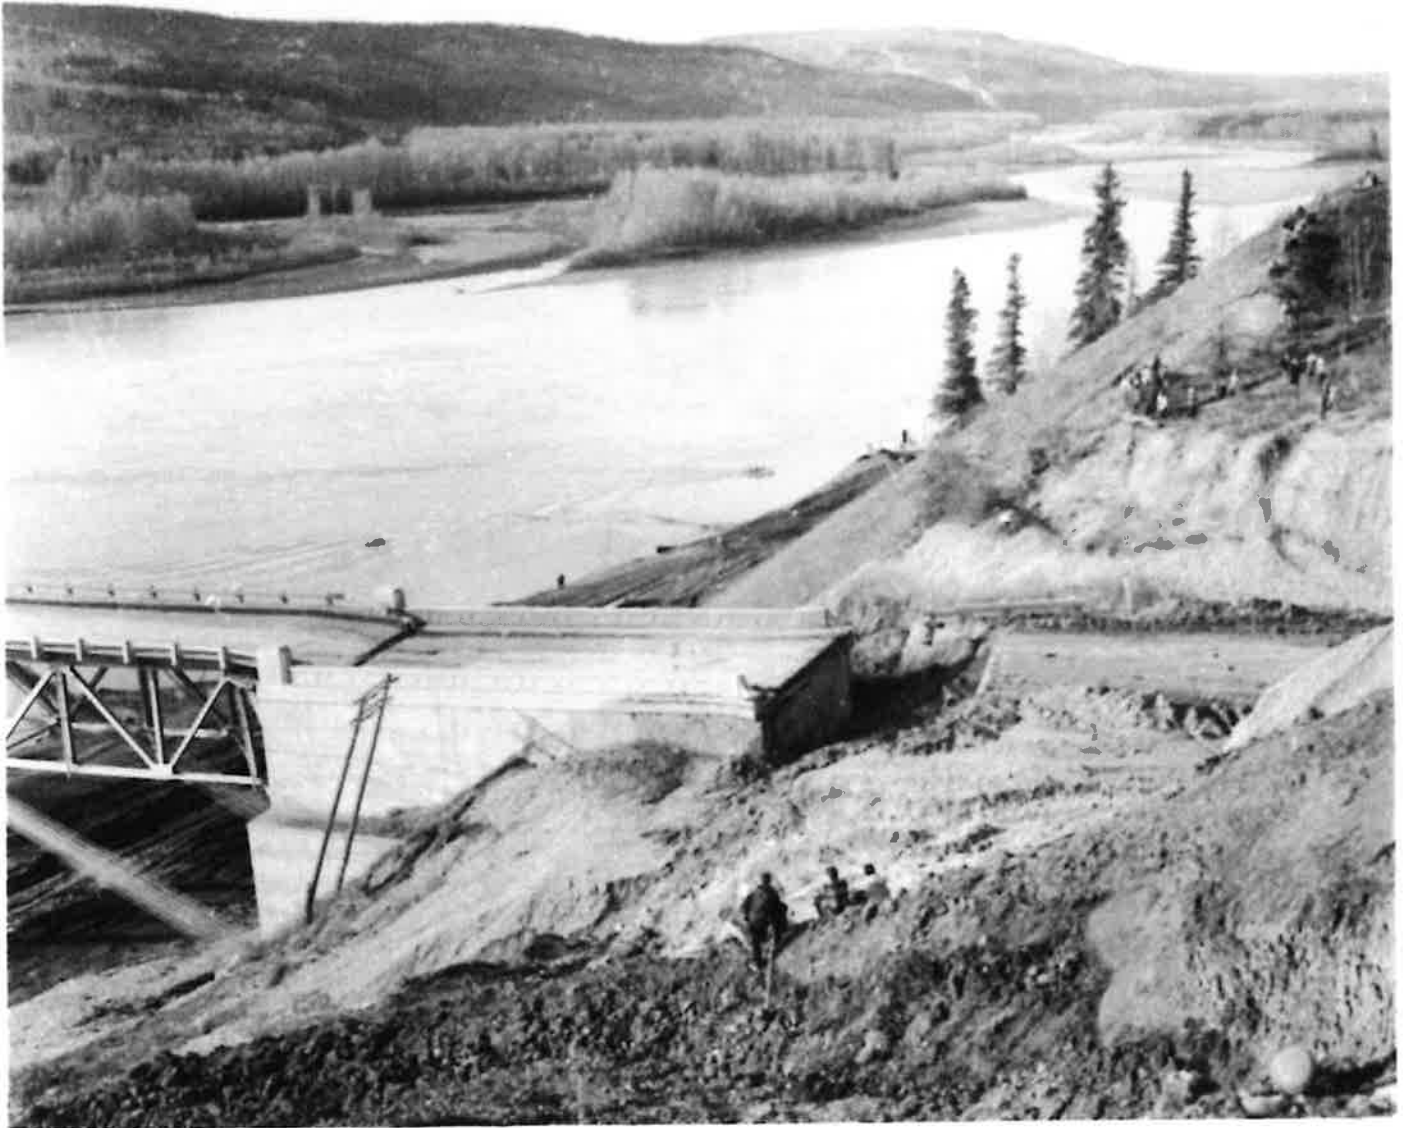
Figure 6. Anchor block and north abutment. Persons give scale.

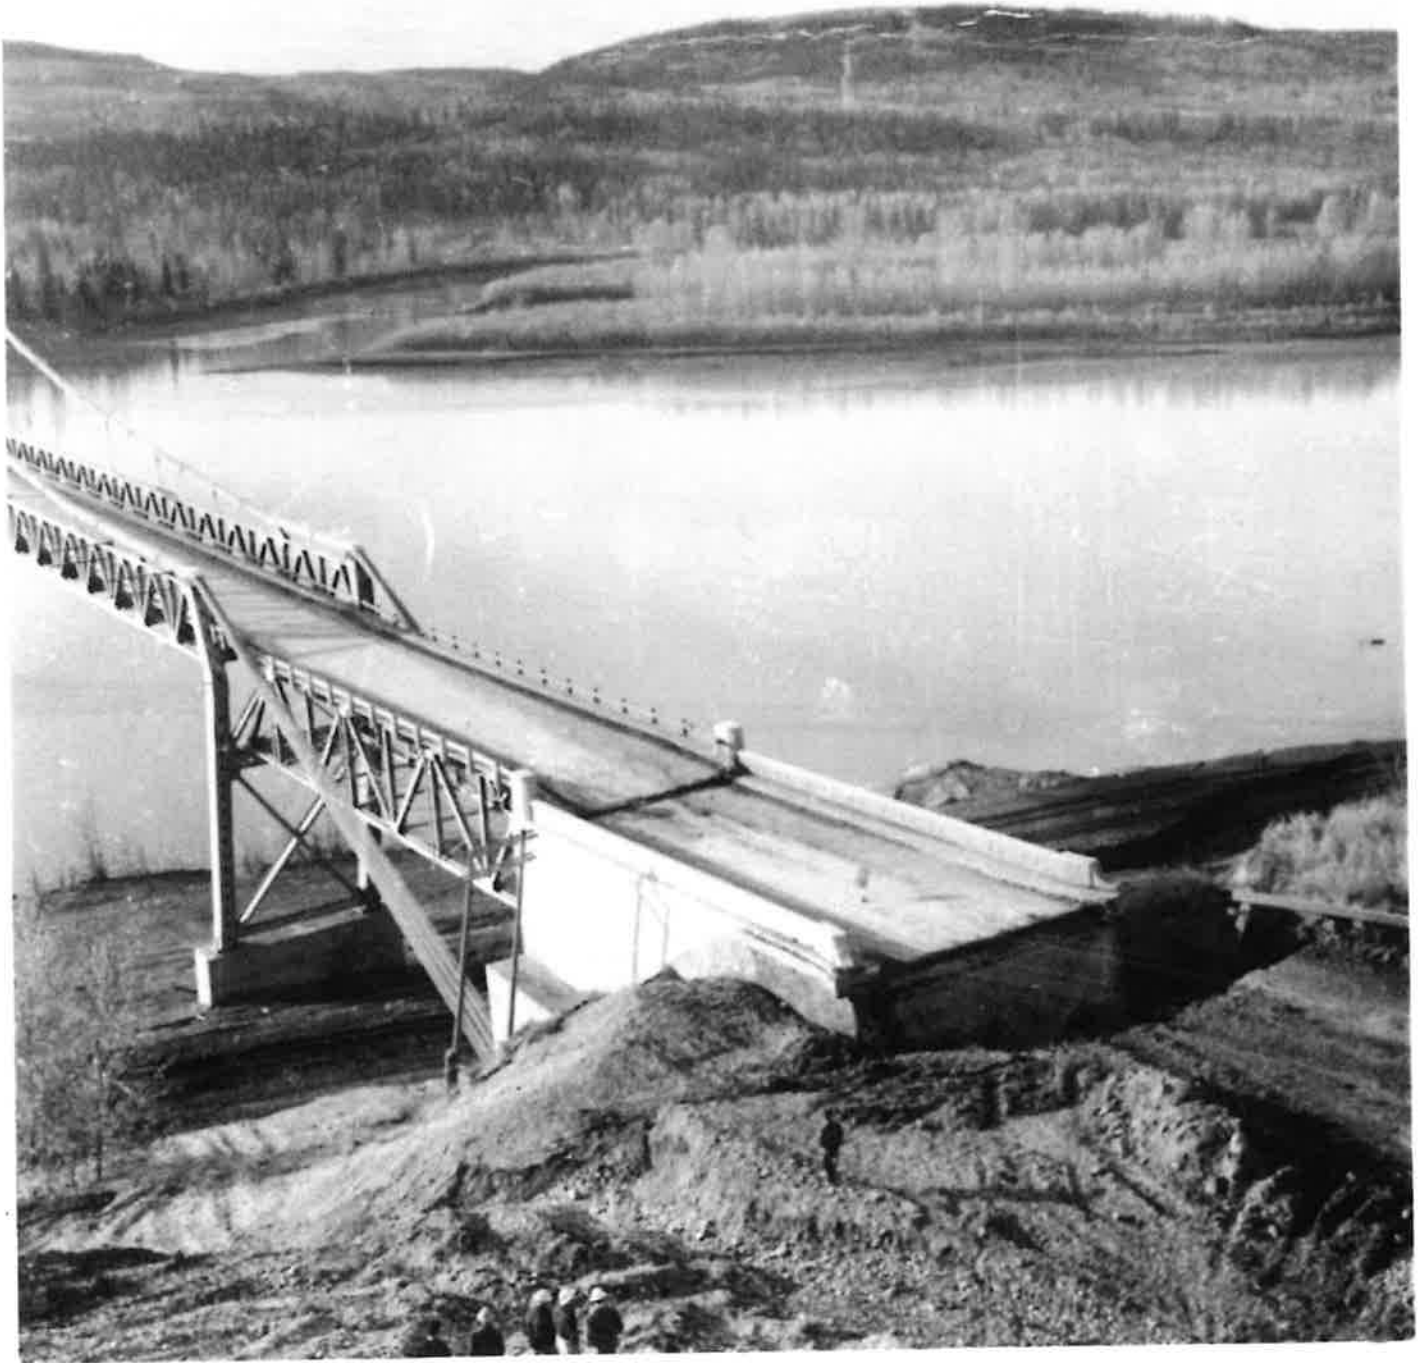
Figure 7. Roadway on abutment has moved under the truss.

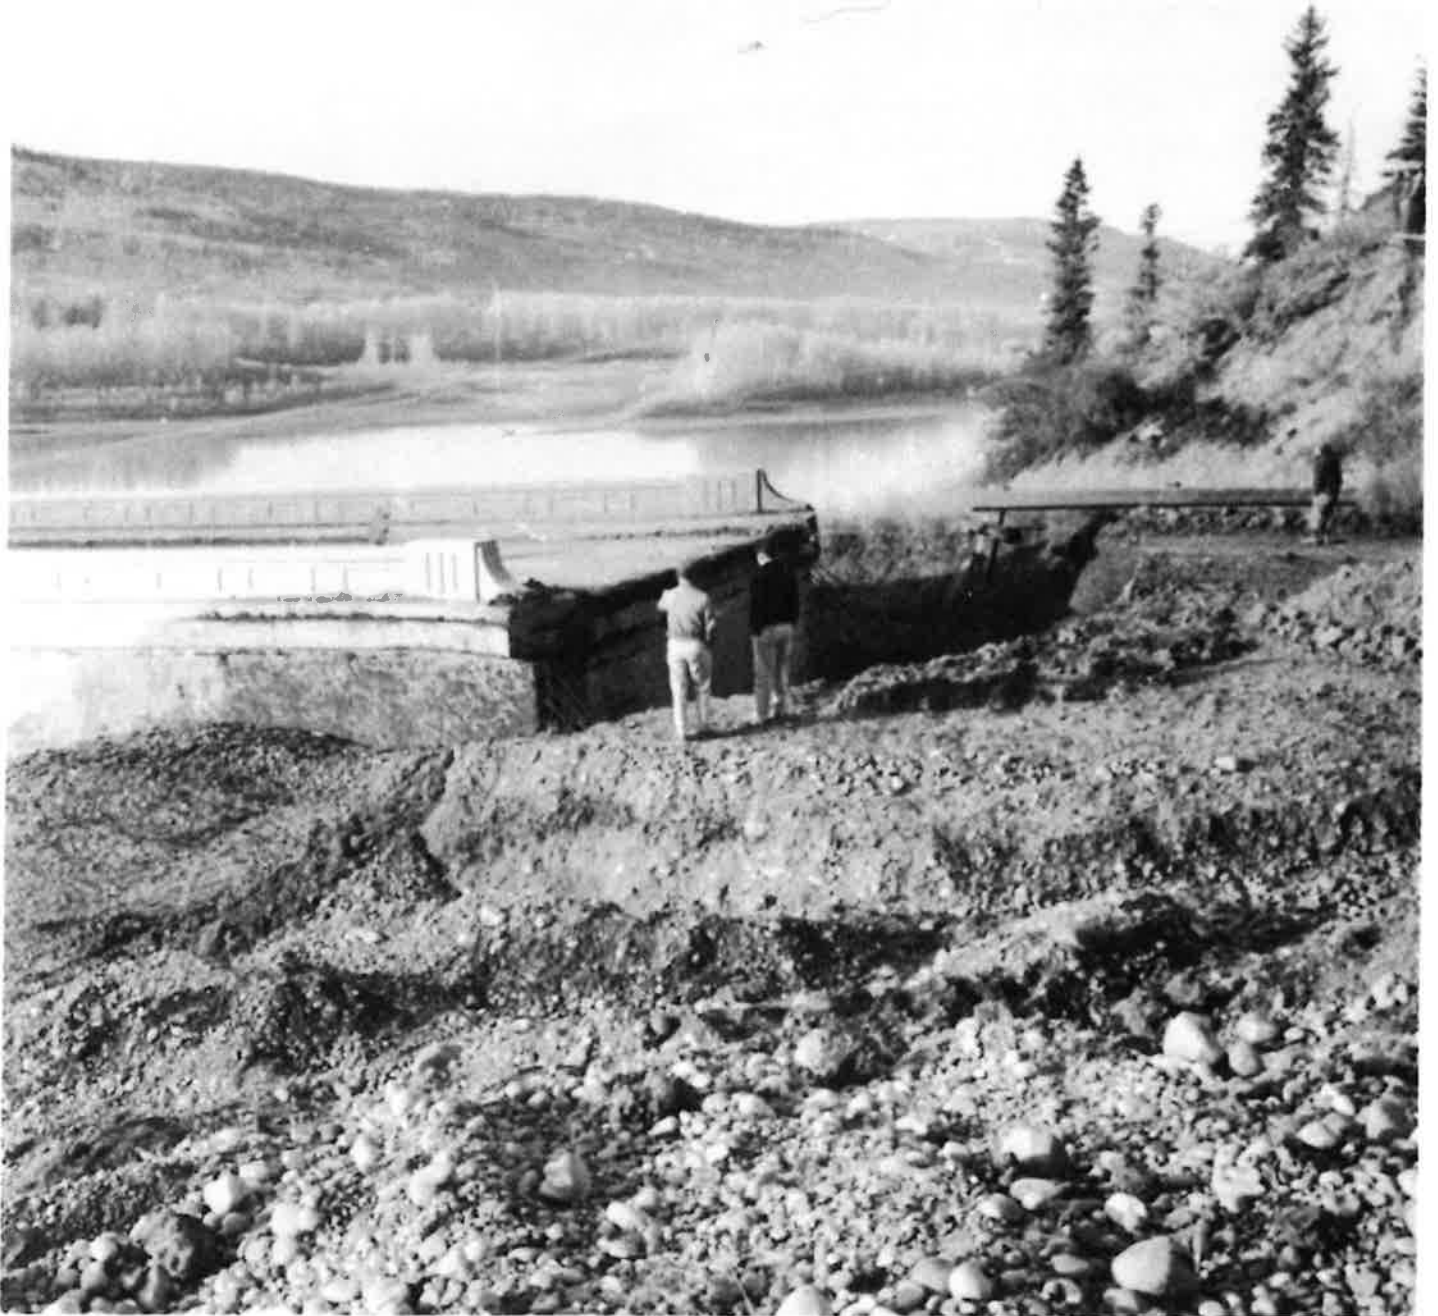
The landslide on the north bank was attributed to the weathering of the shale rock after its disturbance and exposure by the construction of the bridge approach and of the water supply to the natural gas plant. Similar shales, known as clay shales, have since provided challenges to foundation engineers across the Interior Plains. The bridge failure remains an example of the far-reaching consequences of a comparatively small event.

Figure 8. More riverward movement of the anchor block

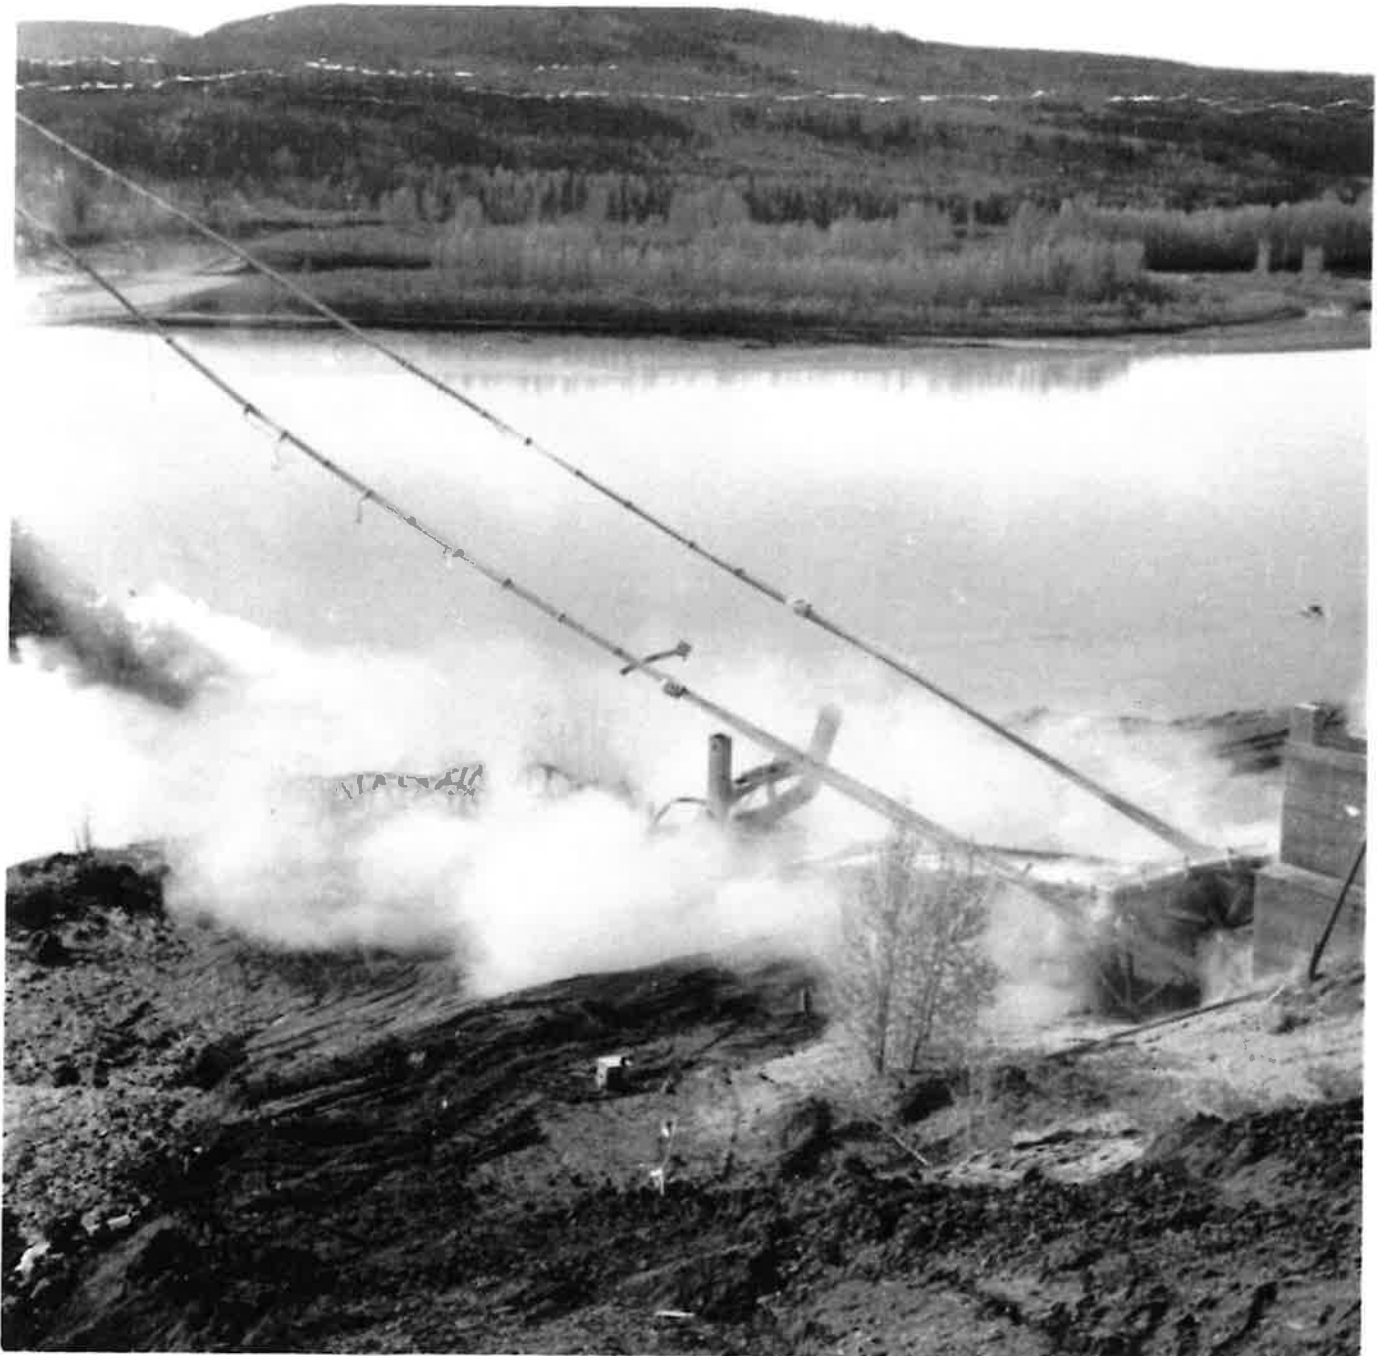
Figure 10. The fall of the north side span and truss

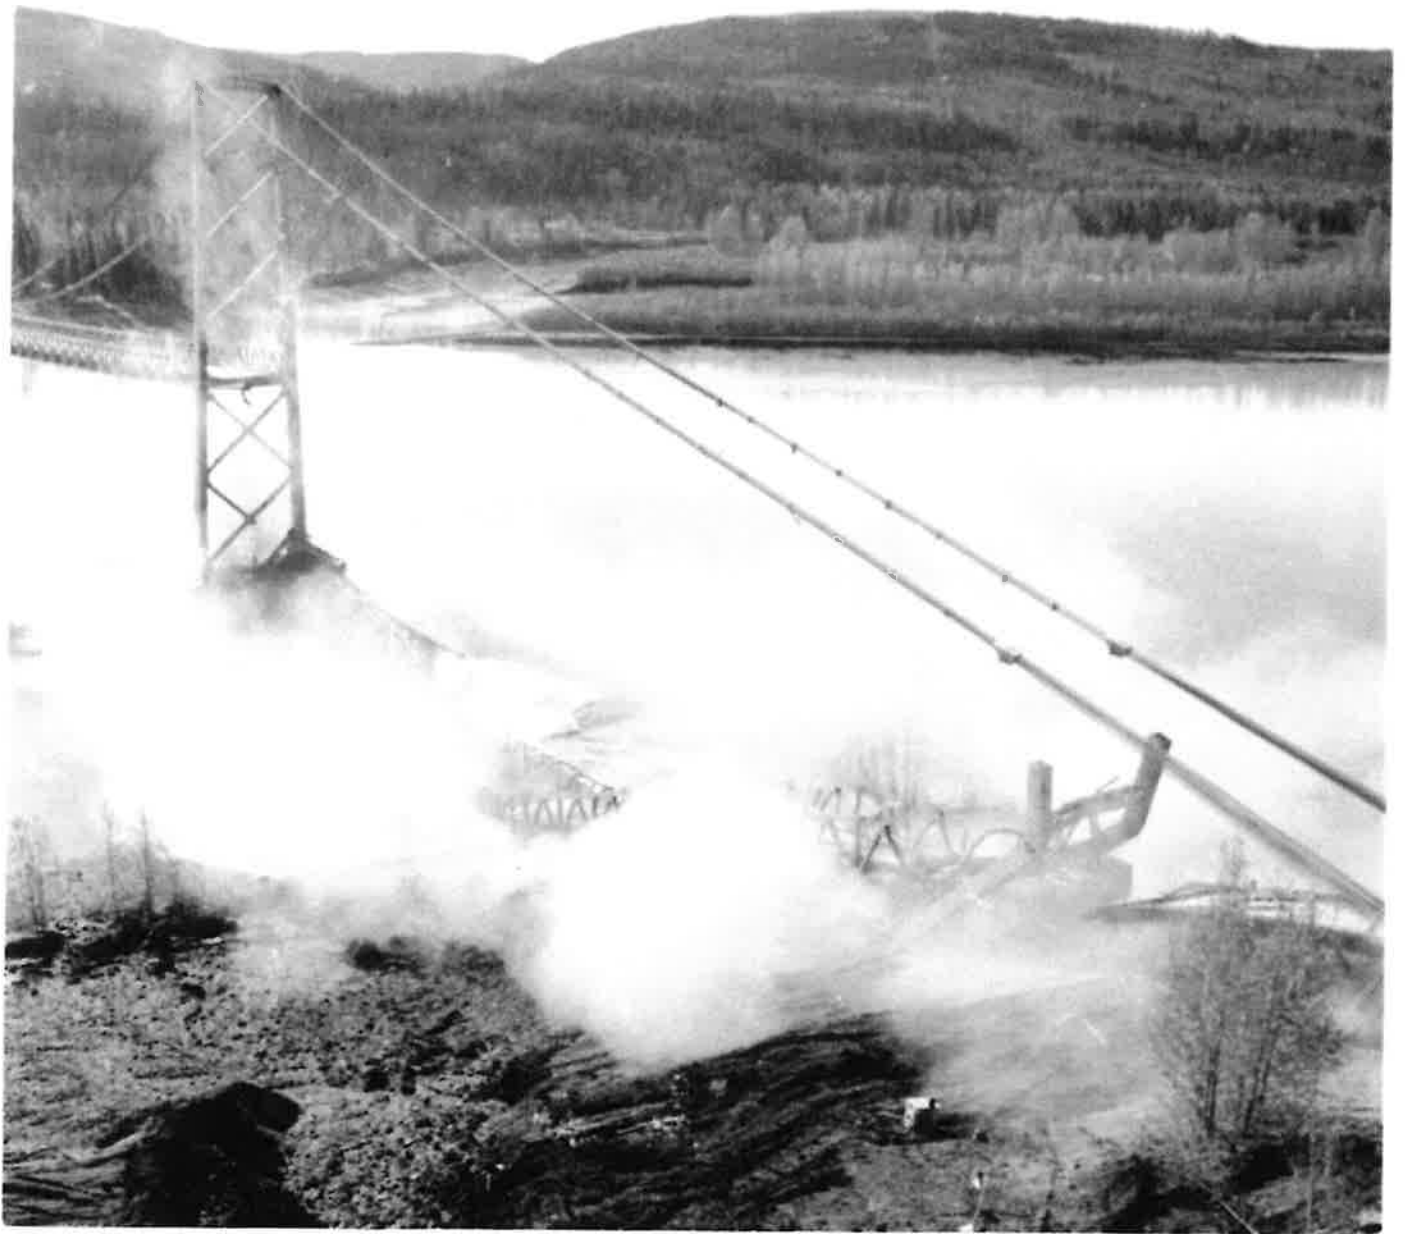
Figure 11. Going

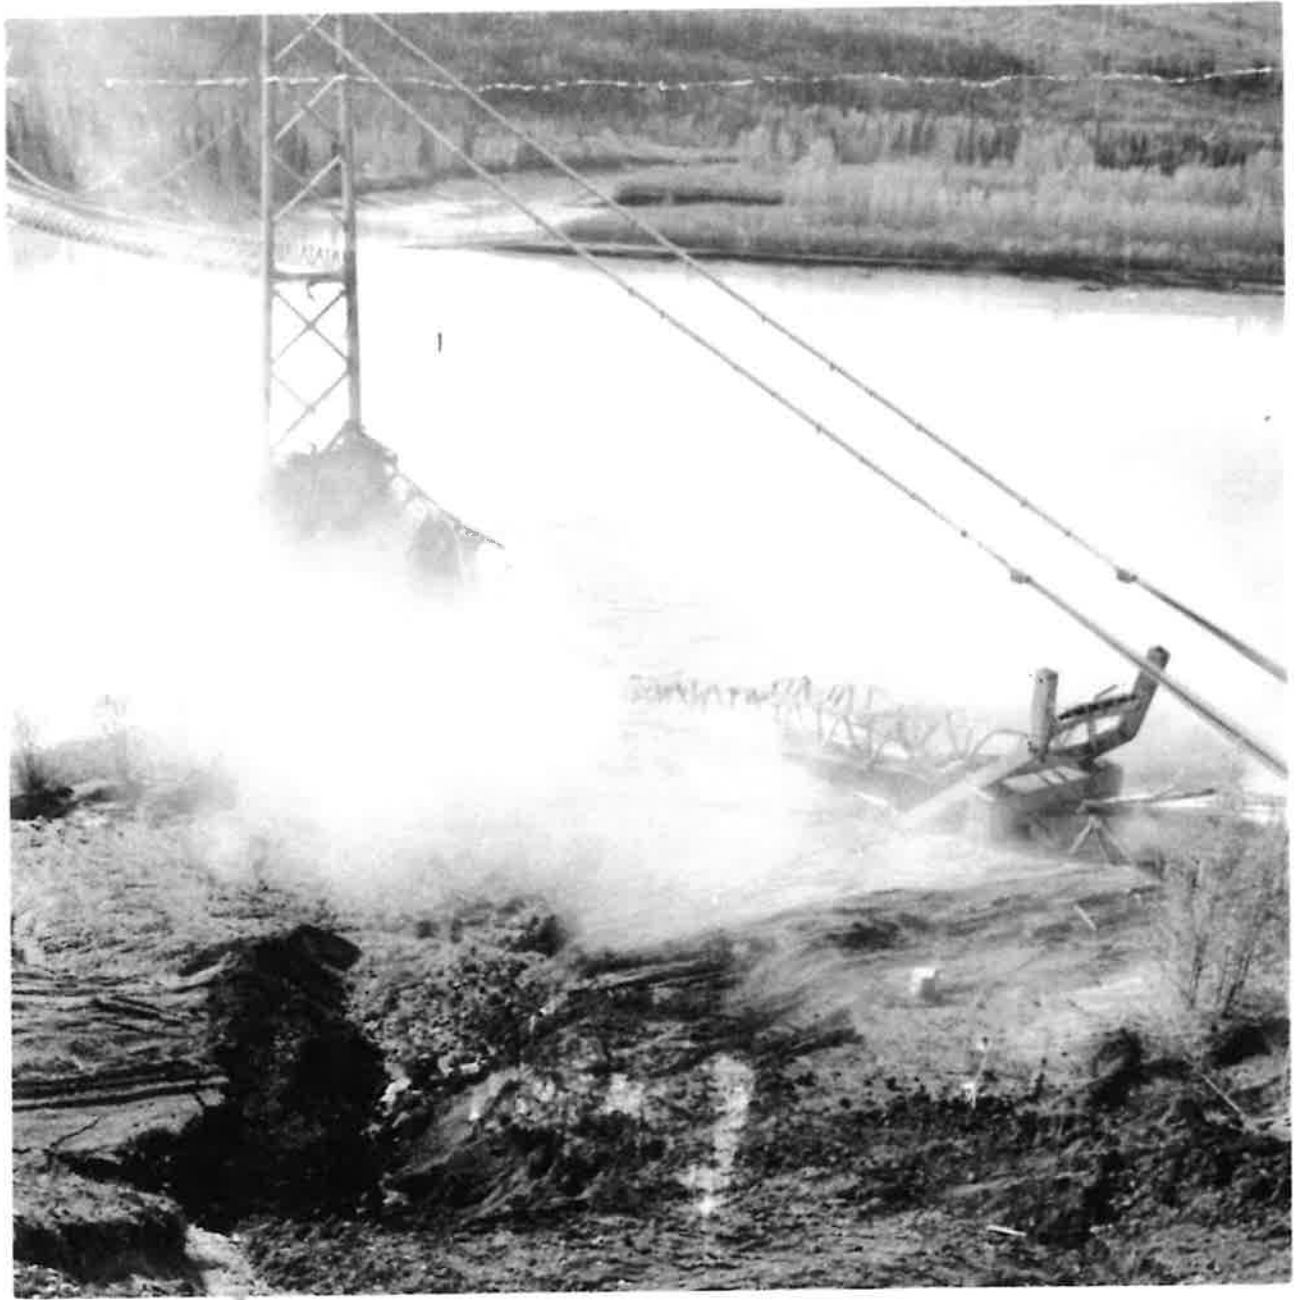
Figure 12. Gone

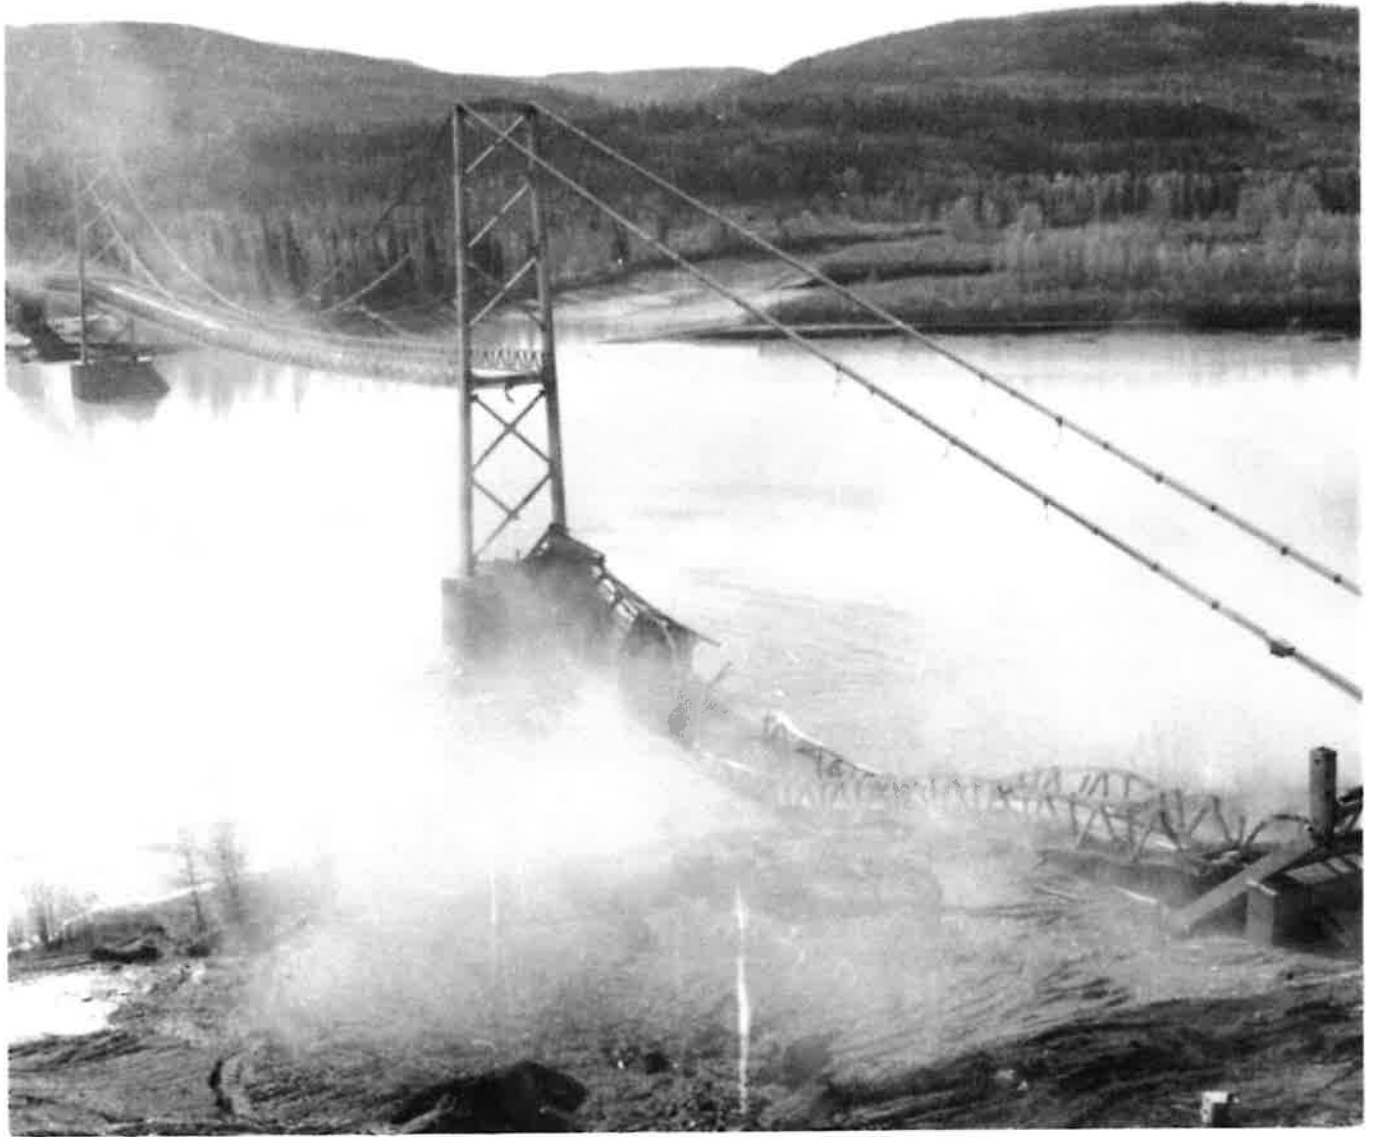
Figure 13. The damaged North Tower stands
